# Analysis of pathological manifestations in the interface between metallic structure and closing system: case study

# Análise de manifestações patológicas na interface entre estrutura metálica e sistemas de fechamento: estudo de caso

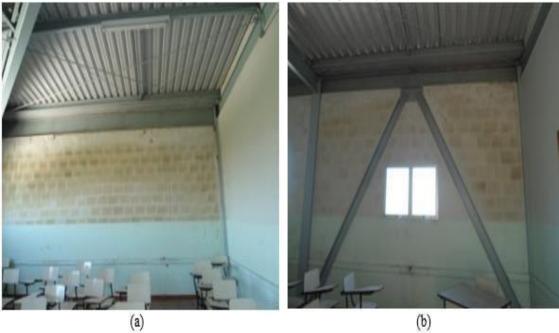
In the building under analysis, there is no adequate treatment at the interface between the structure and the masonry, causing points where moisture or rainfall on the facade penetrate by capillarity in the closing (Figures 3 (a) and 3 (b)). In this case, there was no use of a moisture-resistant finish, nor the use of drip mould on the outside and expansive joints, which allowed for infiltrations and the appearance of stains that highlight the shape of the ceramic bricks in various parts of the façade closure, in the interior of the building.

Figure 3 - Closure with infiltration pathologies

- Installation of deformable joints at the interface between steel beams and masonry;
- Installation of screens in the mortar at the interface between pillars and masonry to prevent the appearance of fissures in this region;
- Recomposition and repainting of the coating after proper fixing of the closure to the structure, ensuring the watertightness of the interfaces;
- Treatment of critical points on the facade, such as installation of drip mould and restoration of the coating;
- Installation of lintels and counter lintels in the openings of the frames to combat the transmission of possible efforts to the closing;
- Cleaning of areas affected by corrosion, elimination of fissures and application of anti-corrosive paint throughout the structure, observing the specification of paint and film thickness that must be correctly indicated;

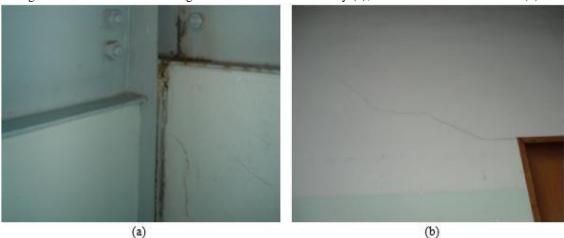
Figure 4 shows the connection region where there was a probable transmission of tensile and/or shear stresses. Such fissures can come from the deformation of the structure due to its loading, masonry shear and hygrothermal movement, in which the temperature variation causes expansion and contraction movements in the building's construction materials, which are normally subject to restrictions by the various constraints of the structure (RIBAS, 2016; Figures 4 (a) and 4 (b)).

Figure 4 – Fissure at the meeting of the structure and masonry (a); Fissure near the door frame (b)

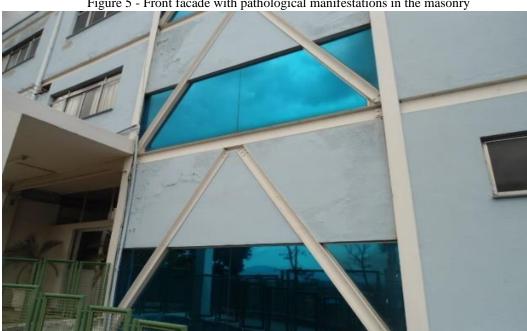
The external facades, in turn, exposed to weathering agents, including moisture, show coating peeling. Figure 5 shows the formation of bubbles in the paint and the

detachment of the paint and mortar. At this point, there is a lack of application of systems that prevent the flow of water at the interface of the facade with the metallic structure, causing infiltration and, consequently, the pathologies shown. It is important to point out that the lack of maintenance and abandonment cause a series of damages that could often be avoided with preventive correction measures (SANTOS; FIORITI; TSUTSUMOTO, 2016). However, with the appearance of long-term pathological manifestations, the adoption of corrective measures becomes necessary and must be frequent.

Figure 5 - Front facade with pathological manifestations in the masonry

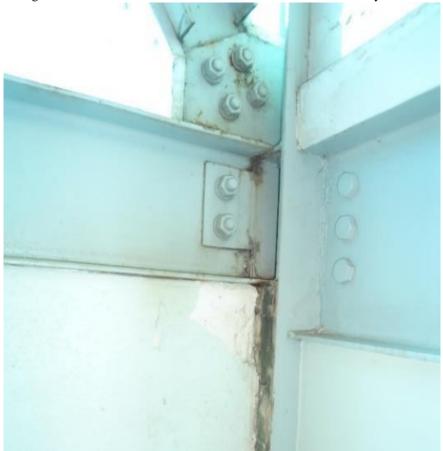
It is clear, at the interface points of the structure with the masonry, where the fixation occurs only by contact, that the action of external agents or bad weather causes the pathological effects that spread not only in the masonry, but also in the structural elements themselves (Figure 6).

Figure 6 - Corrosion due to infiltration at the structure and masonry interface

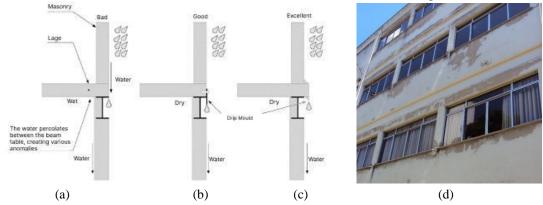
With these considerations and taking into account the technical approach, the meticulous detailing regarding the geometry of the constructive elements can, then, influence the occurrence of critical points in the building. One of these details can be seen in Figure 7 (a), in which the linkage of the structure with the closure without proper protection of the system promotes the penetration of moisture, causing pathologies. Measures adopted in projects can avoid such problems (Figures 7 (b) and 7 (c)).

It can be seen from the constructive aspect of the facade of the building under study, portrayed in Figure 7 (d), that the example in Figure 7 (a) shows the same situation

Figure 7 – Constructive detail of the structure interface (a), (b) e (c); Constructive aspect of the facade (d)

throughout the facade. A treatment for the problem would be the application of a drip mould, shown in the examples of Figures 7 (b) and 7 (c).

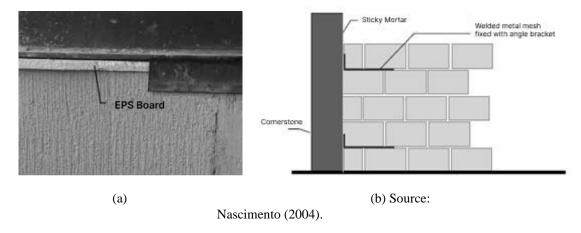
Figure 8 – EPS board joint at the masonry and structure interface (a); Detail lateral fixing of the masonry with pillar (b)

In addition to the possibility of infiltration on the upper surface of the beam, moisture may penetrate the lower surface in contact with the masonry. The treatment, in this case, differs a little from the previous one, since, in addition to the drip mould detail, it is recommended to create a flexible joint with expansive material, which can be expanded polyurethane (PU) or expanded polystyrene (EPS), in the contact of the masonry with the beam at the top. For deformable systems, lateral confinement can be adopted by applying angles (Figure 8 (a)), due to the need to absorb the effects of movement of the structure without transmitting significant portions of efforts to the masonry (NASCIMENTO, 2004; BELLEI, 2006). The proper fixing of the masonry to the structure tends to guarantee both watertightness and deformability to the system. A fixation error can lead to compromised deformation and the occurrence of fissures. It is indicated to observe the positioning in each row, ensuring the alignment of the bricks. When laying the brick, place welded metal meshes carefully on the mortar, ensuring that the mortar has a thickness of around 20 mm to 30 mm, adjusting the leveling and covering of the mesh before laying the next layer of bricks (Figure 8). (B)).
